KEELS CREEK STREAMBANK RESTORATION

FLOODING THREATENS EXISTING UTILITIES

TURTLE CREEK STREAMBANK RESTORATION

UTILITIES AND WATER RESOURCES PROTECTED

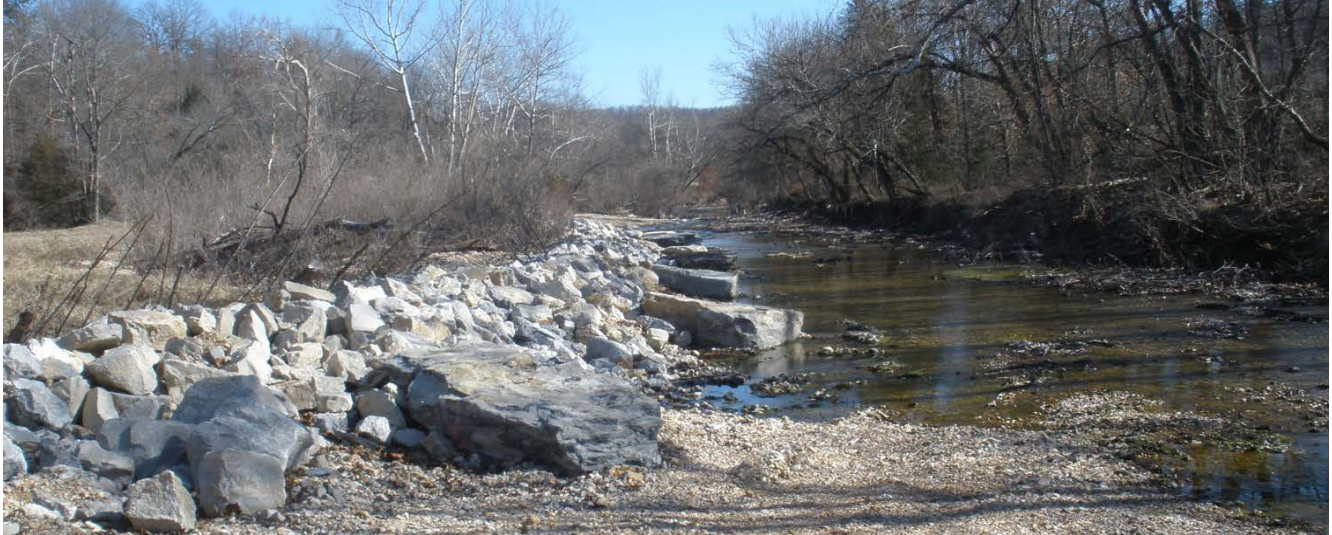
At one area of the creek, the bank had eroded to within 3 to 4 feet of the CBWD transmission line. Due to the emergency nature of the project, MWY took a “design build” approach to mitigate the crisis. Working with Corps of Engineers, Arkansas Natural Resources Commission, Arkansas Department of Environmental Quality and Environmental Consulting Operations, permits were acquired and a design plan was formulated.

Mitigation of the streambank consisted of removal of existing creek gravel to create pools to slow the flow of water in the creek, constructing a Longitudinal Peak Stone Toe Protection (LPSTP) structure to “armor” the streambank as well as Bendway Weirs and engineered rock riffles to help channel the flows within the creek away from the embankment. Improvements also included the planting of Willow Trees within the LPSTP structure and in the creek bed to assist in the mitigation of water velocities in Keels Creek. Sycamore Trees were also used in certain areas along the streambank to create a more natural erosion barrier and to help mitigate possible future erosion.

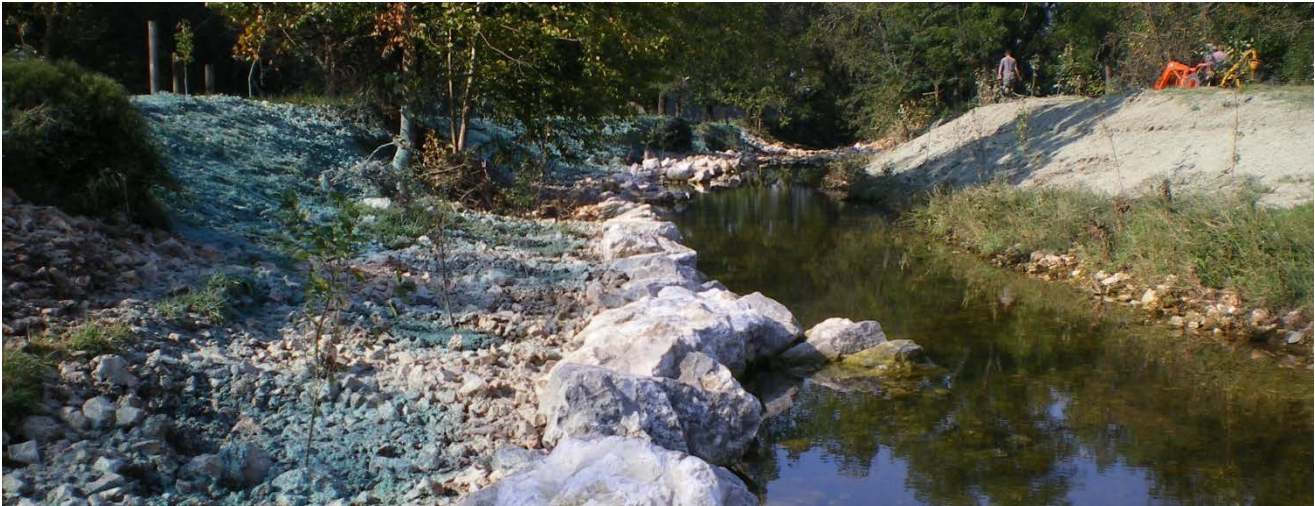
Mitigation included the construction of a Longitudinal Peak Stone Toe Protection (LPSTP) structure, engineered rock riffles, rock vanes, the planting of approximately 300 trees and mulching disturbed areas with a bonded fiber matrix to expedite the establishment of vegetation along the creek bank. The total project site included approximately 2,800 linear feet of creek and streambank restoration, which encompassed approximately 3.0 acres.

To protect the utility lines, approximately 300 linear feet of the LPSTP structure was constructed to “armor” the streambank and prevent future erosion. The engineered rock riffles and the rock vanes were then constructed within the creek bed to assist in maintaining the creek channel flows primarily in the center of Turtle Creek and away from the stream embankment. The planting of 300 trees - River Birch, Black Willow and Bur Oak, along each side of the embankment and the application of the bonded fiber matrix vegetation mixture to the disturbed areas helped stabilize the embankment as well as assist in returning this section of Turtle Creek into its natural riparian state.
